**Flood Control Project Maintenance  
Levee Inspections**  
**LMA District Cover Sheet**  
**Spring 2017 Levee Inspection Results**

**Reclamation District No. 0524 Middle Roberts Island**

**Spring 2017 Levee Inspection Results**

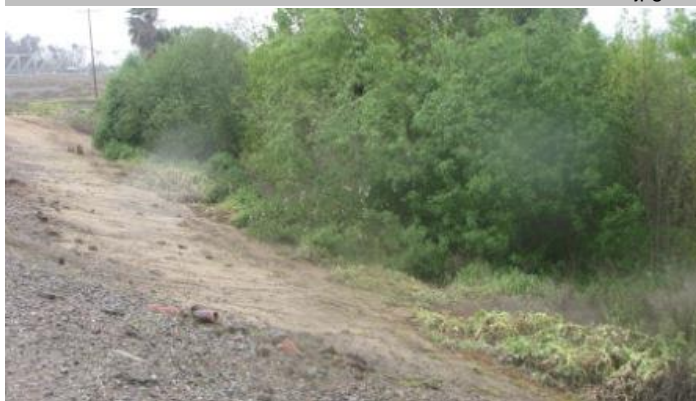
Photo 4 of 4 : SP\_2017\_RD0524\_107\_915\_20170316\_00272.jpg

Looking southwest at dense veg. on landside toe. (Fall 2015)

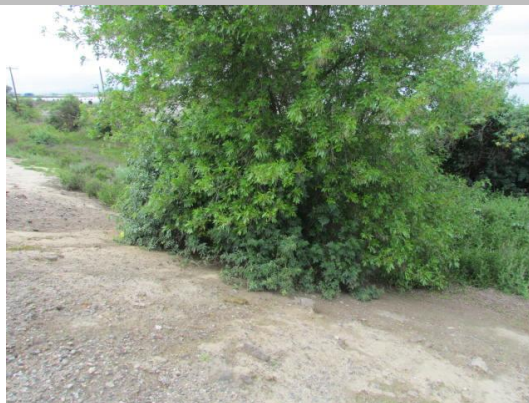
Photo 1 of 1 : SP\_2017\_RD0524\_107\_206\_20170316\_00239.jpg

LM Start	1.17	Rating **	U	Issue No.	206
LM End	1.17	Issue Type +	Ma	Location *	LS
Category	Earthen Levee			GPS Latitude/Longitude	
				Start	End
Item	Trim / Thin Trees			37.933591 °	37.933591 °
				-121.329154 °	-121.329154 °
DWR ID	DWR_RD0524_01_s_2016_206				
Comment Code					
T1 : Trim trees to at least five feet above ground level.					
Inspector Comment

Looking southwest a untrimmed tree at landward toe. (Spring 2016)

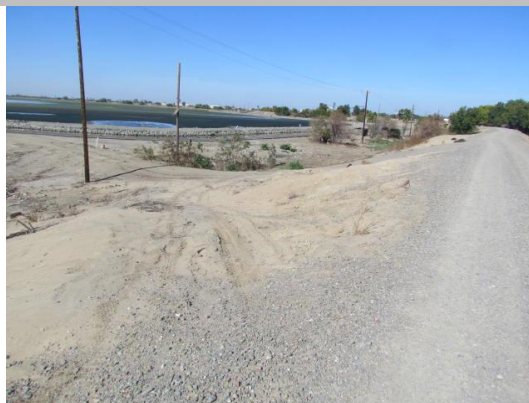
Photo 1 of 2 : SP\_2017\_RD0524\_107\_263\_20170316\_00264.jpg

LM Start	1.25	Rating **	U	Issue No.	263
LM End	1.25	Issue Type +	En	Location *	LS
Category	Earthen Levee			GPS Latitude/Longitude	
				Start	End
Item	Encroachments			37.932533 °	37.932533 °
				-121.328650 °	-121.328650 °
DWR ID	DWR_RD0524_01_s_2012_263				
Comment Code					
RA : Ramp					
Inspector Comment					
Unauthorized ramps on landside slope. Ramps were caused by vehicle traffic.

Looking northwest at unauthorized ramp on landside slope.

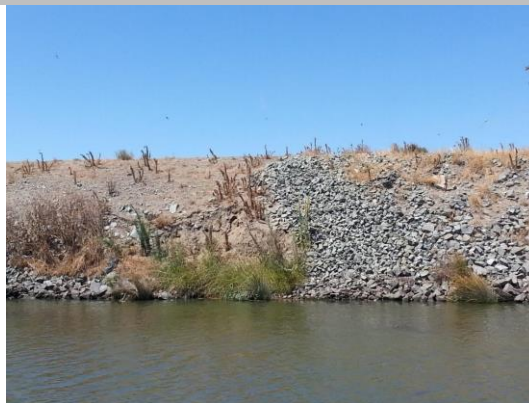
Photo 1 of 3 : SP\_2017\_RD0524\_107\_71\_20170316\_00115.jpg

LM Start	1.29	Rating **	U	Issue No.	71
LM End	1.32	Issue Type +	Ma	Location *	WS
Category	Supplemental			GPS Latitude/Longitude	
				Start	End
Item	DWR Erosion Survey			37.931858 °	37.931858 °
				-121.328300 °	-121.328300 °
DWR ID	DWR_RD0524_01_s_2017_71				
Comment Code					
Inspector Comment					
07/25/2016: No significant change observed.					
06/24/2015: No significant change observed.					
06/19/2014: No significant change observed.					
08/13/2013: New signs of animal activity were found.					
08/07/2012: The site was first reported in 2012 spring levee inspection report. [2016 Site ID:RD0524U01RM41.92]

Front view of the erosion.

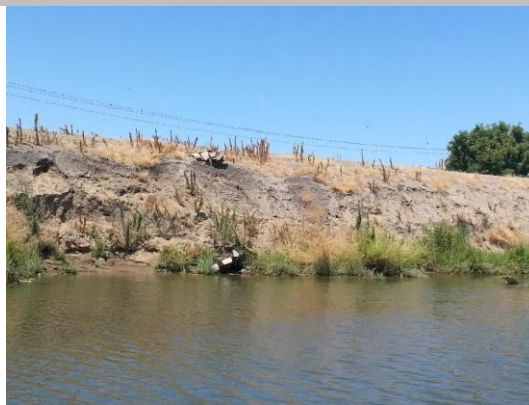
Photo 2 of 3 : SP\_2017\_RD0524\_107\_71\_20170316\_00116.jpg

Front view of the erosion.

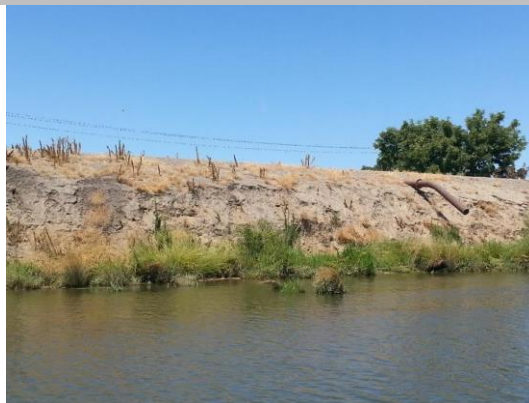
Photo 3 of 3 : SP\_2017\_RD0524\_107\_71\_20170316\_00117.jpg

Front view of the erosion. Note the drainage pipe on the site.

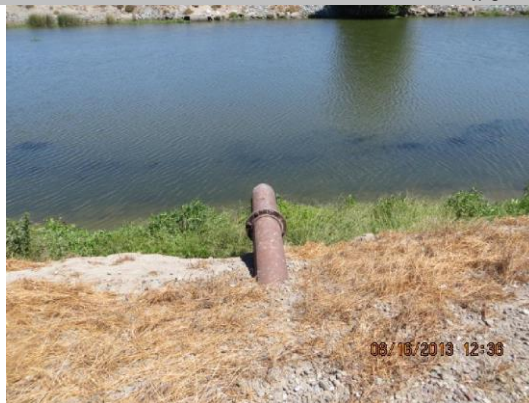
Photo 1 of 3 : UCIP\_SP\_2017\_51319\_29862.jpg

FS\_ID:51319  
DS\_ID:20602  
EP\_NO: N/A  
Repair Type: Urgent  
Crossing Status: Found  
UCIP Comments: 11/16/2016 same as previous inspection both ends are open. This pipe does not appear in use. Need to contact owner to determine status of crossing. If the crossing is abandoned or in use, owner will need to coordinate with the CVFPB to comply with Title 23 requirements. (O. Magana - DWR UCIP)08/16/2013 Pipe appears to be open on both ends. Abandoned and should be done so properly. (W. Wylie - DWR UCIP)  
FIELD\_STRUCT\_DESC: \*ABANDONED\* 12-inch steel drainage pipe through levee, 3.5 feet below crown. Pipe is opened on the waterside (WS) and landside (LS) ends. The pump house referenced in O&M manual is missing from the LS (2013). [Additional Reference(s): DWR Levee Log, 2004. USACE San Joaquin River O&M Unit No. 7, April 1964, (HLM 1.31)].  
FS Date: 11/16/2016

Pipe visible and open on WS slope.

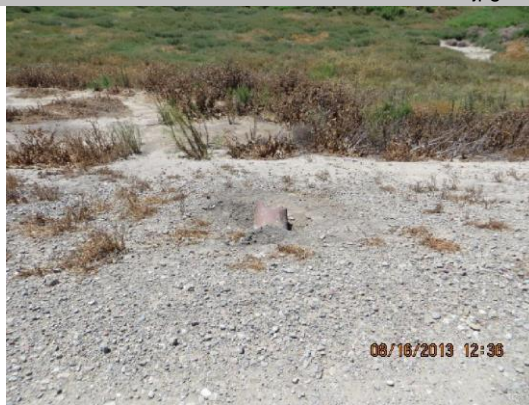
Photo 2 of 3 : UCIP\_SP\_2017\_51319\_29861.jpg

Pipe open and visible on LS slope.

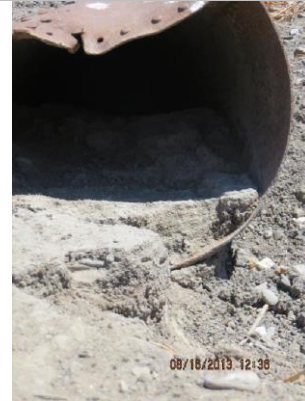
Photo 3 of 3 : UCIP\_SP\_2017\_51319\_29860.jpg

Comment Code					
Inspector Comment					
FS_ID:51319 DS_ID:20602 EP_NO: N/A Repair Type: Urgent Crossing Status: Found UCIP Comments: 11/16/2016 same as previous inspection both ends are open. This pipe does not appear in use. Need to contact owner to determine status of crossing. If the crossing is abandoned or in use, owner will need to coordinate with the CVFPB to comply with Title 23 requirements. (O. Magana - DWR UCIP)08/16/2013 Pipe appears to be open on both ends. Abandoned and should be done so properly. (W. Wylie - DWR UCIP) FIELD_STRUCT_DESC: *ABANDONED* 12-inch steel drainage pipe through levee, 3.5 feet below crown. Pipe is opened on the waterside (WS) and landside (LS) ends. The pump house referenced in O&M manual is missing from the LS (2013). [Additional Reference(s): DWR Levee Log, 2004. USACE San Joaquin River O&M Unit No. 7, April 1964, (HLM 1.31)]. FS Date: 11/16/2016

Pipe appears open on both ends. View from LS slope.

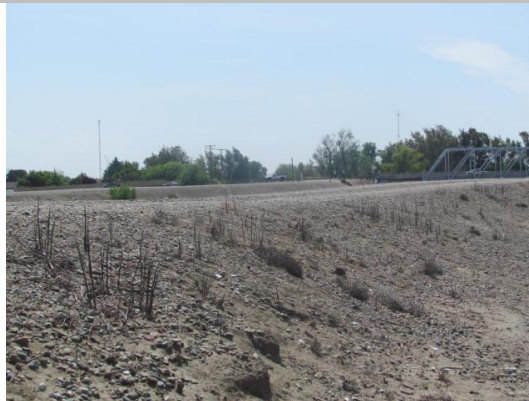
Photo 1 of 2 : SP\_2017\_RD0524\_107\_172\_20170316\_00201.jpg

LM Start	1.36	Rating **	U	Issue No.	172
LM End	1.40	Issue Type +	Ma	Location *	CR
Category	Earthen Levee			GPS Latitude/Longitude	
				Start	End
Item	Crown Surface / Depressions / Rutting			37.931085 °	37.930517 °
				-121.328112 °	-121.328072 °
DWR ID	DWR_RD0524_01_s_2015_172				
Comment Code					
C2 : Repair depressions or ruts in the crown or slope.					
Inspector Comment					
Levee crown depression several inches below original crown elevation. Section should be survey to determine proper elevation.

Looking east at depression on levee crown.

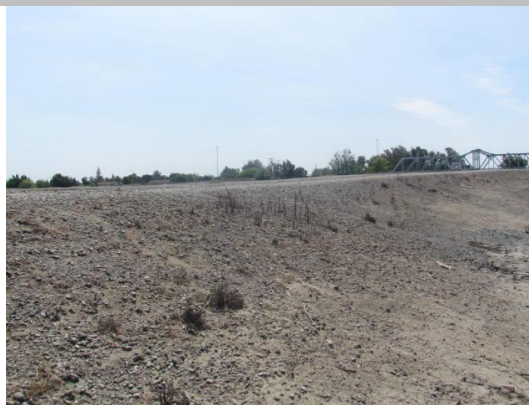
Photo 2 of 2 : SP\_2017\_RD0524\_107\_172\_20170316\_00202.jpg

Looking southeast at depression on levee crown.

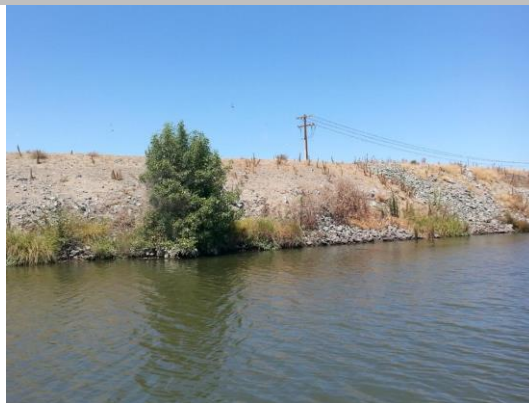
Photo 1 of 3 : SP\_2017\_RD0524\_107\_79\_20170316\_00127.jpg

LM Start	1.39	Rating **	U	Issue No.	79
LM End	1.39	Issue Type +	Ma	Location *	WS
Category	Supplemental			GPS Latitude/Longitude	
				Start	End
Item	DWR Erosion Survey			37.930575 °	37.930575 °
				-121.328090 °	-121.328090 °
DWR ID	DWR_RD0524_01_s_2017_79				
Comment Code					
Inspector Comment					
07/25/2016: No significant change observed					
06/24/2015: No significant change observed.					
06/19/2014: No significant change observed.					
08/13/2013: No significant change observed.					
08/07/2012: The site was first reported in 2012 spring levee inspection report. The site is located about 750 ft downstream of SR 4 Bridge.					
[2016 Site ID:RD0524U01RM42.03]

Front view of the erosion.

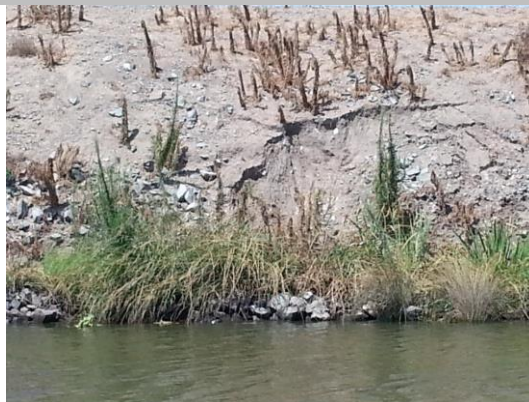
Photo 2 of 3 : SP\_2017\_RD0524\_107\_79\_20170316\_00128.jpg

Close view of the erosion.

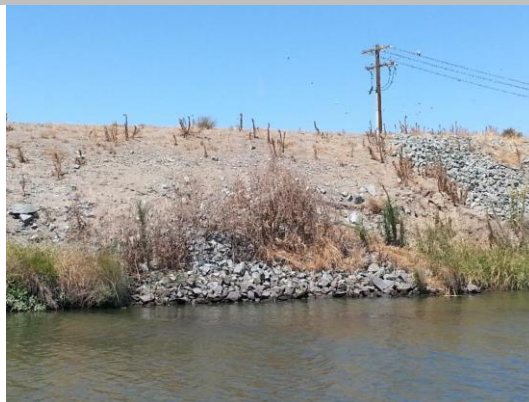
Photo 3 of 3 : SP\_2017\_RD0524\_107\_79\_20170316\_00129.jpg

Close view of the erosion.

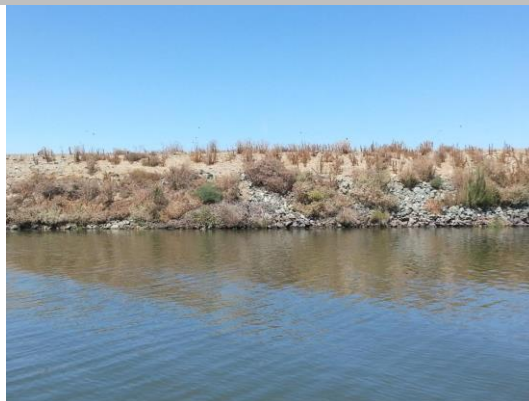
Photo 1 of 2 : SP\_2017\_RD0524\_107\_89\_20170316\_00142.jpg

LM Start	1.45	Rating **	U	Issue No.	89
LM End	1.47	Issue Type +	Ma	Location *	WS
Category	Supplemental			GPS Latitude/Longitude	
				Start	End
Item	DWR Erosion Survey			37.929650 °	37.929650 °
				-121.328110 °	-121.328110 °
DWR ID	DWR_RD0524_01_s_2017_89				
Comment Code					
Inspector Comment					
07/25/2016: No significant change observed.					
06/24/2015: No significant change observed.					
06/19/2014: No significant change observed.					
08/13/2013: The site is located approximately 400 ft. downstream SR 4 Bridge. Dense vegetation is visible at the toe. [2016 Site ID:RD0524U01RM42.09]

Close view of the erosion. Note the vegetation at the site.

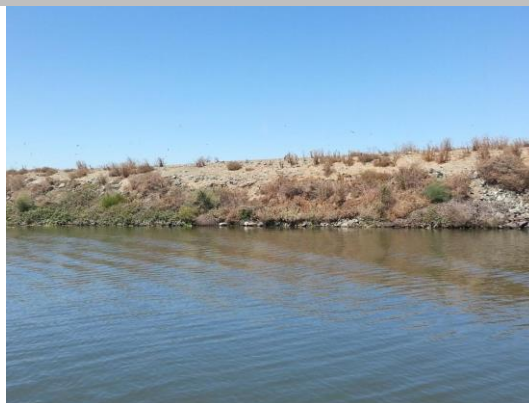
Photo 2 of 2 : SP\_2017\_RD0524\_107\_89\_20170316\_00143.jpg

Close view of the erosion.

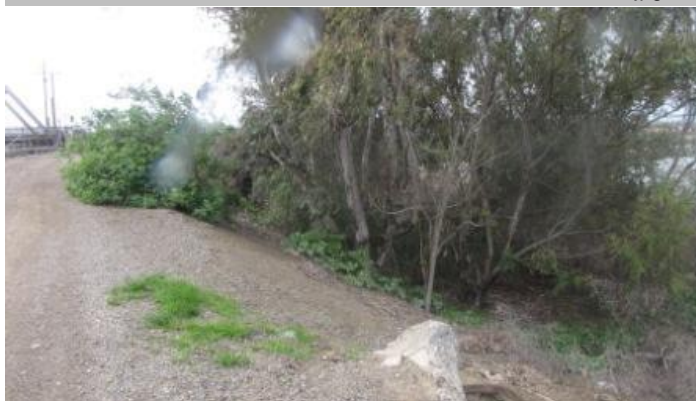
Photo 3 of 4 : SP\_2017\_RD0524\_107\_916\_20170316\_00275.jpg

Looking at dense veg. on landside slope and toe.

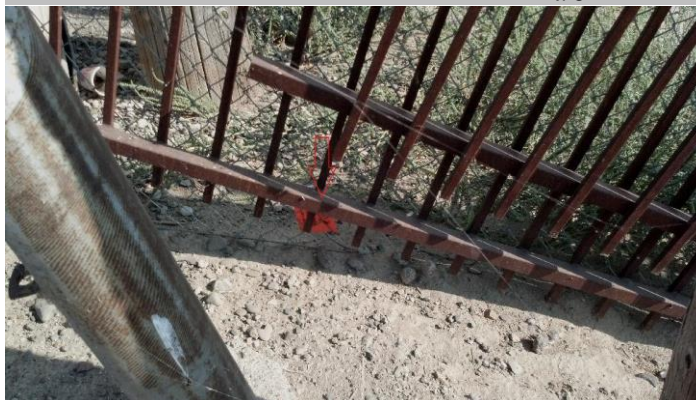
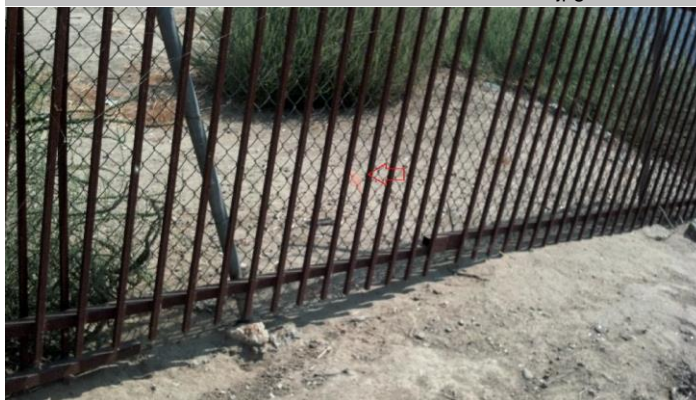
FS\_ID:17798  
DS\_ID:20605  
EP\_NO: N/A  
Repair Type: Non-Urgent  
Crossing Status: Indicator Found  
UCIP Comments: No permit identified for this crossing.  
FIELD\_STRUCT\_DESC: Fiber optics cable crossing. USAA marker flags over crown along alignment of gate.  
FS Date: 8/20/2013

USAA markers along alignment at gate.

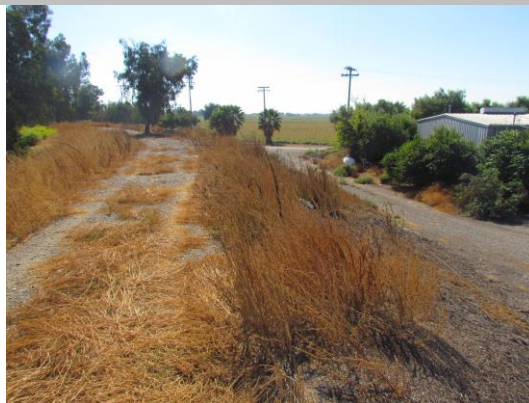
Photo 1 of 1 : SP\_2017\_RD0524\_107\_23\_20170316\_00048.jpg

LM Start	1.55	Rating **	A/W	Issue No.	23
LM End	1.59	Issue Type +	Ma	Location *	LS
Category	Earthen Levee			GPS Latitude/Longitude	
				Start	End
Item	Vegetation			37.928388 °	37.927797 °
				-121.328280 °	-121.327854 °
DWR ID	DWR_RD0524_01_s_2012_23				
Comment Code					
V2 : Remove the wild growth other than native grasses from the levee slopes.					
Inspector Comment					
Dense vegetation on landward slope.

Looking southwest at dense veg on landward slope. (Fall 2016)

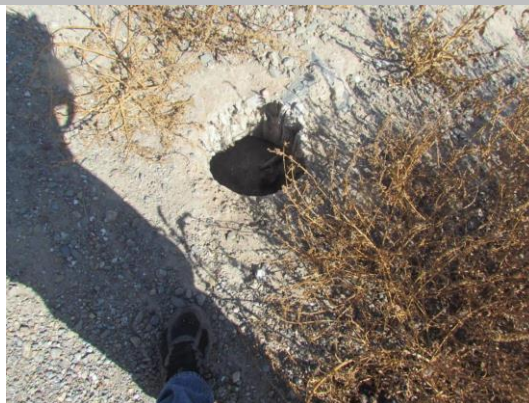
Photo 2 of 2 : SP\_2017\_RD0524\_107\_202\_20170316\_00234.jpg

LM Start	1.55	Rating **	U	Issue No.	202
LM End	1.55	Issue Type +	Ma	Location *	WS
Category	Earthen Levee			GPS Latitude/Longitude	
				Start	End
Item	Erosion / Bank Caving			37.928372 °	37.928372 °
				-121.328283 °	-121.328283 °
DWR ID	DWR_RD0524_01_f_2016_202				
Comment Code					
E2 : Schedule repair of erosion site prior to the next inspection.					
Inspector Comment					
Large hole (looks like fences post or telephone pole) on waterward shoulder.

Looking at large hole (Fence/telephone post hole) on waterward shoulder.

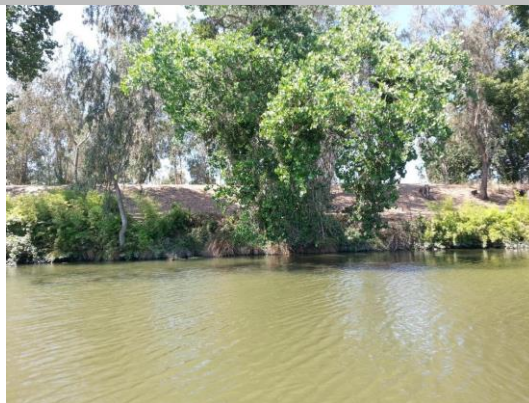
Photo 1 of 3 : SP\_2017\_RD0524\_107\_90\_20170316\_00144.jpg

Comment Code					
Inspector Comment					
07/25/2016: No significant change observed.					
06/24/2015: No significant change observed.					
06/19/2014: No significant change observed.					
08/13/2013: No significant change observed.					
08/07/2012: The site has been visited by boat survey. No significant change observed					
08/23/2011: No significant change observed on site. Trees concerned still in place.					
09/07/2010: No significant change observed on site. The concern here is the undermining of the levee toe where most of trees are. There are erosion pockets lined along the lower slope and at the base of the trees, exposing tree roots. There is minimal slope protection.					
09/29/2009: The lower slope is lined with minor erosion pockets; some tree roots are exposed; there is visible undermining of the levee toe; site is immediately upstream of the Highway 4 Bridge; the bridge is possibly causing a scour to occur, eroding the bank. [2016 Site ID:RD0524U01RM42.2]

Front view of the site where undermining has occurred.

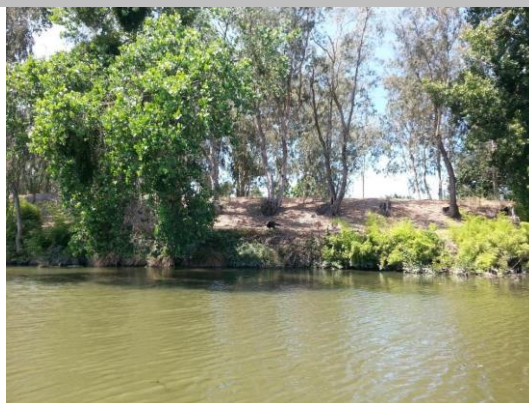
Photo 2 of 3 : SP\_2017\_RD0524\_107\_90\_20170316\_00145.jpg

Close view of the erosion.

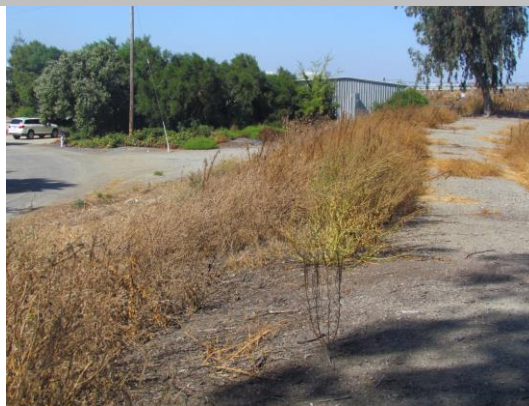
Photo 1 of 1 : SP\_2017\_RD0524\_107\_24\_20170316\_00049.jpg

LM Start	1.60	Rating **	U	Issue No.	24
LM End	1.61	Issue Type +	Ma	Location *	LS
Category	Earthen Levee			GPS Latitude/Longitude	
				Start	End
Item	Vegetation			37.927635 °	37.927540 °
				-121.327812 °	-121.327648 °
DWR ID	DWR_RD0524_01_s_2012_24				
Comment Code					
V2 : Remove the wild growth other than native grasses from the levee slopes.					
Inspector Comment					
Vegetation blocking landward toe.

Looking northwest at dense veg on waterward slope.

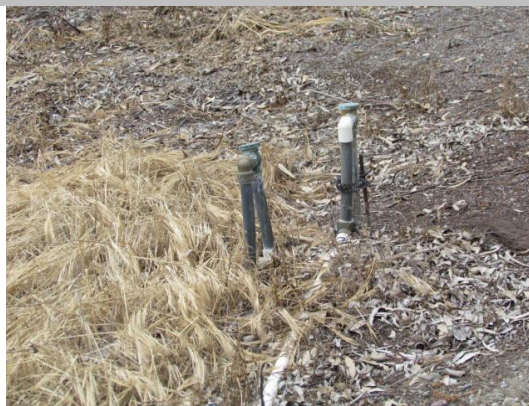
Photo 1 of 2 : SP\_2017\_RD0524\_107\_207\_20170316\_00240.jpg

LM Start	1.65	Rating **	M	Issue No.	207
LM End	1.71	Issue Type +	En	Location *	LS
Category	Earthen Levee			GPS Latitude/Longitude	
				Start	End
Item	Encroachments			37.927237 °	37.926621 °
				-121.327183 °	-121.326400 °
DWR ID	DWR_RD0524_01_s_2016_207				
Comment Code					
LI : Landscape Irrigation					
Inspector Comment					
Sprinklers on landward shoulder

Looking south at sprinkler line and sprinklers on landward shoulder.

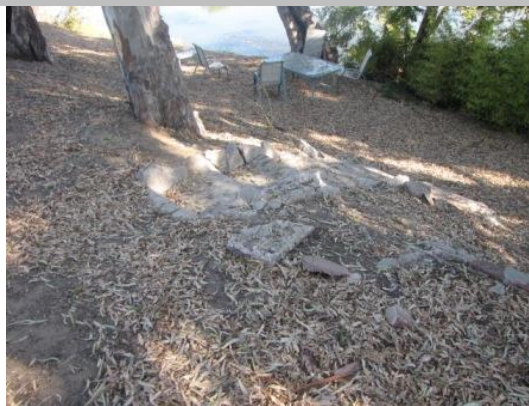
Photo 1 of 3 : SP\_2017\_RD0524\_107\_45\_20170316\_00082.jpg

LM Start	1.67	Rating **	U	Issue No.	45
LM End	1.67	Issue Type +	Ma	Location *	WS
Category	Earthen Levee			GPS Latitude/Longitude	
				Start	End
Item	Encroachments			37.927018 °	37.927018 °
				-121.326872 °	-121.326872 °
DWR ID	DWR_RD0524_01_s_2012_45				
Comment Code					
ST : Stairway					
Inspector Comment					
Stairs and retaining wall

Looking northeast at non-permitted concrete stairs on waterside slope.

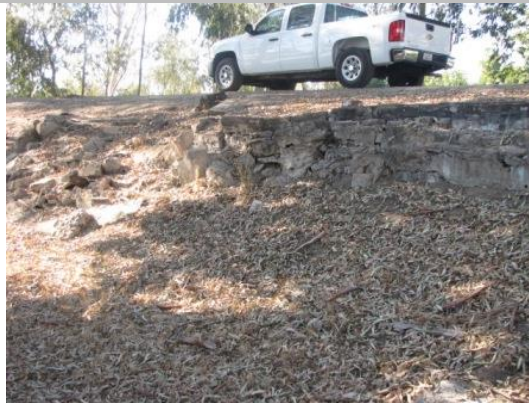
Photo 2 of 3 : SP\_2017\_RD0524\_107\_45\_20170316\_00083.jpg

LM Start	<b>1.67</b>	Rating **	U	Issue No.	<b>45 (cont)</b>
LM End	<b>1.67</b>	Issue Type +	Ma	Location *	WS

Looking southwest at retaining wall connected to concrete stairs.

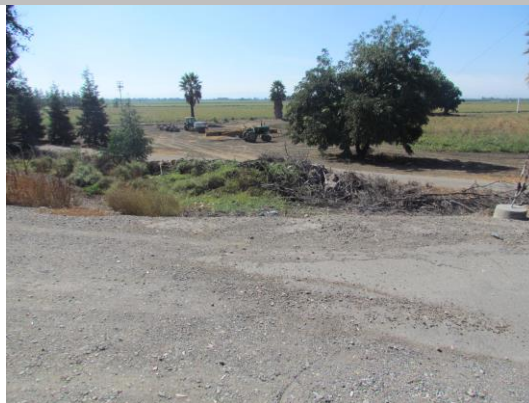
Photo 1 of 1 : SP\_2017\_RD0524\_107\_28\_20170316\_00057.jpg

LM Start	1.73	Rating **	U	Issue No.	28
LM End	1.73	Issue Type +	En	Location *	LS
Category	Earthen Levee			GPS Latitude/Longitude	
				Start	End
Item	Encroachments			37.926322 °	37.926322 °
				-121.326115 °	-121.326115 °
DWR ID	DWR_RD0524_01_s_2012_28				
Comment Code					
GA : Garbage					
Inspector Comment					
Large pruning piles on landside slope.

Looking west at pruning and garbage piles at landward berm.

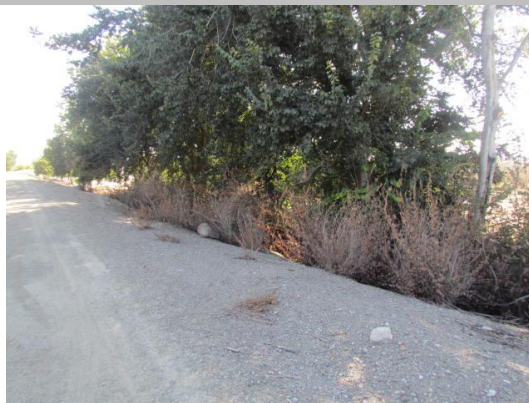
Photo 4 of 4 : SP\_2017\_RD0524\_107\_46\_20170316\_00088.jpg

LM Start	1.75	Rating **	U	Issue No.	46 (cont)	
LM End	1.76	Issue Type +	Ma	Location *	LS	
Category	Earthen Levee			GPS Latitude/Longitude		
				Start	End	
Item	Encroachments			37.926152 °	37.925993 °	
				-121.325927 °	-121.325777 °	
DWR ID	DWR_RD0524_01_s_2012_46					
Comment Code						
TR : Tree or limb						
Inspector Comment						
Downed tree limbs on landward slope.

Looking southwest at dense vegetation and low hanging tree branches on landside slope and toe.

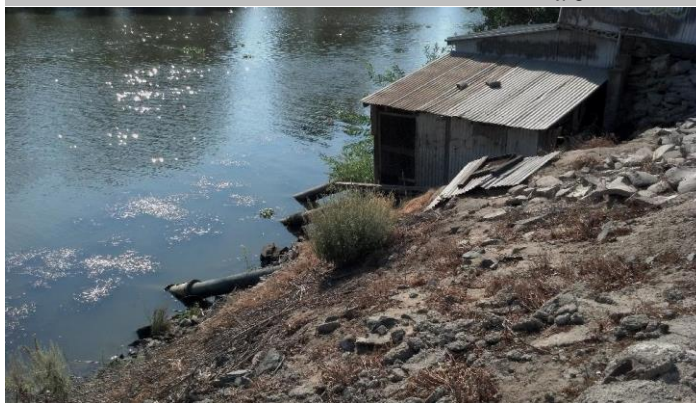
Photo 1 of 3 : UCIP\_SP\_2017\_21866\_37124.jpg

LM Start	1.80	Rating **	M	Issue No.	943
LM End	1.80	Issue Type +	En	Location *	LS
Category	Supplemental			GPS Latitude/Longitude	
				Start	End
Item	DWR UCIP Field Study			37.925480 °	37.925480 °
				-121.325358 °	-121.325358 °
DWR ID					
Comment Code					
Inspector Comment					
FS_ID:21866 DS_ID:24032 EP_NO: N/A Repair Type: Non-Urgent Crossing Status: Found UCIP Comments: No permit identified for crossing. FIELD_STRUCT_DESC: 12-inch wrapped steel irrigation pipe through the levee at an unknown depth below the crown. Pump, butterfly valves, vent, and siphon breaker at concrete pad 50-feet off LS toe. Siphon breaker in 14-inch concrete standpipe on LS shoulder. FS Date: 8/20/2013

Pipe visible at lower left.

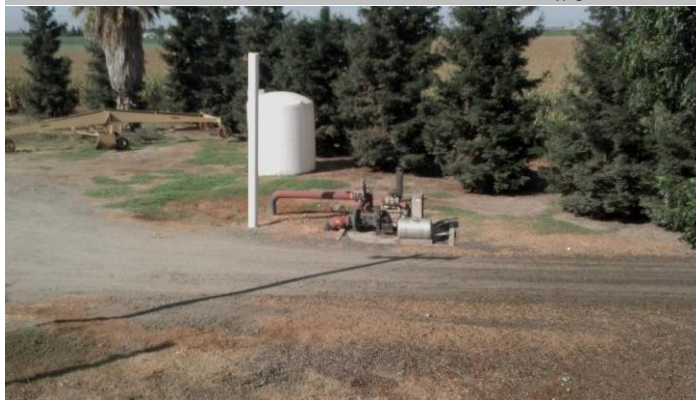
Photo 2 of 3 : UCIP\_SP\_2017\_21866\_37123.jpg

FS\_ID:21866  
DS\_ID:24032  
EP\_NO: N/A  
Repair Type: Non-Urgent  
Crossing Status: Found  
UCIP Comments: No permit identified for crossing.  
FIELD\_STRUCT\_DESC: 12-inch wrapped steel irrigation pipe through the levee at an unknown depth below the crown. Pump, butterfly valves, vent, and siphon breaker at concrete pad 50-feet off LS toe. Siphon breaker in 14-inch concrete standpipe on LS shoulder.  
FS Date: 8/20/2013

Pumping plant off LS toe.

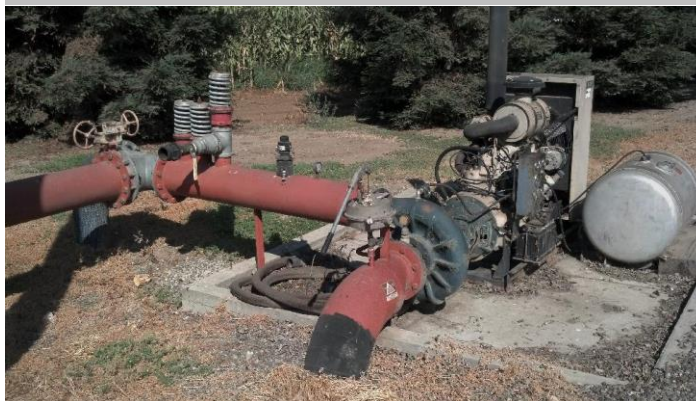
Photo 3 of 3 : UCIP\_SP\_2017\_21866\_37122.jpg

Pumping plant with siphon breaker, vents, and butterfly valves.

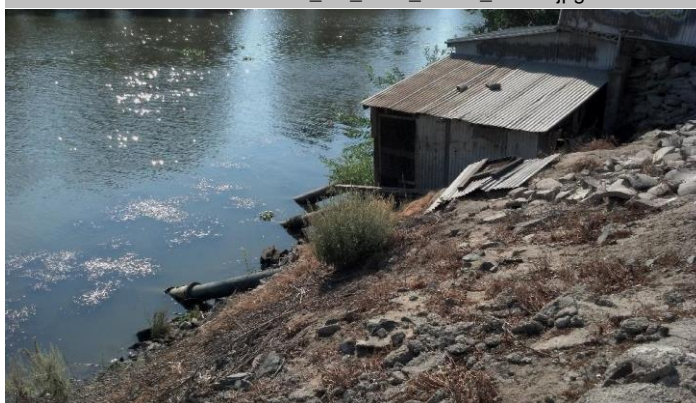
Photo 1 of 3 : UCIP\_SP\_2017\_17847\_29962.jpg

LM Start	1.81	Rating **	M	Issue No.	944
LM End	1.81	Issue Type +	En	Location *	LS
Category	Supplemental			GPS Latitude/Longitude	
				Start	End
Item	DWR UCIP Field Study			37.925429 °	37.925429 °
				-121.325323 °	-121.325323 °
DWR ID					
Comment Code					
Inspector Comment					
FS_ID:17847					
DS_ID:20609					
EP_NO: N/A					
Repair Type: Non-Urgent					
Crossing Status: Found					
UCIP Comments: Pipe appears abandoned and if so should be done so properly.					
FIELD_STRUCT_DESC: 14-inch pipe through levee 20.0 feet below crown, 2 pumps and gate valves discharge into surge tank in pump house on the waterward slope. Concrete distribution box removed from the waterward slope. Abandoned 36-inch diameter concrete standpipe on LS toe next to service pole. Originally included in the 1964 O&M manual.					
FS Date: 8/20/2013

Pipes and pumphouse on WS slope.

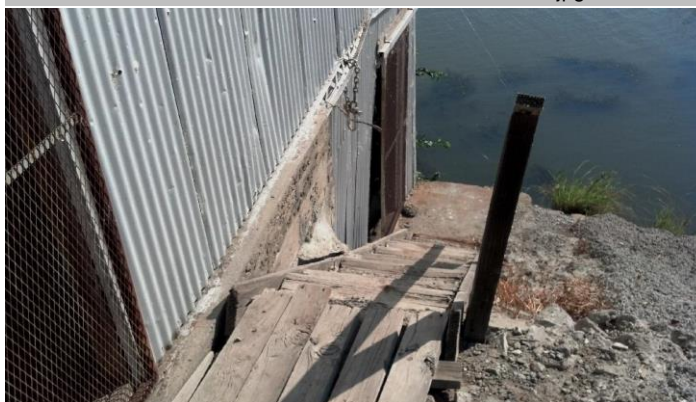
Photo 2 of 3 : UCIP\_SP\_2017\_17847\_29961.jpg

Steps to pump on WS slope.

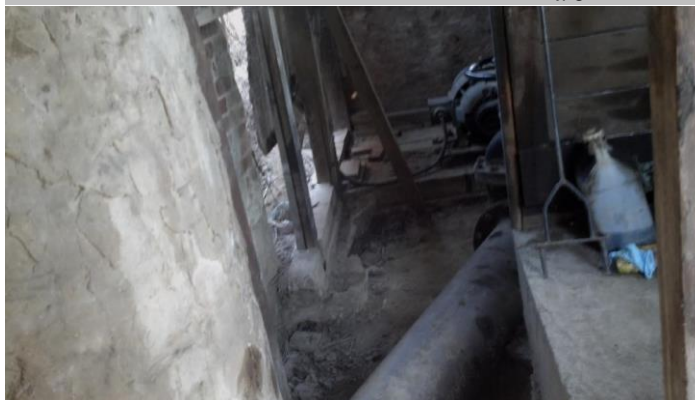
Photo 3 of 3 : UCIP\_SP\_2017\_17847\_29960.jpg

LM Start	1.81	Rating **	M	Issue No.	944 (cont)	
LM End	1.81	Issue Type +	En	Location *	LS	
Category	Supplemental			GPS Latitude/Longitude		
				Start		End
Item	DWR UCIP Field Study			37.925429 °	37.925429 °	
				-121.325323 °	-121.325323 °	
DWR ID						
Comment Code						
Inspector Comment						
FS_ID:17847						
DS_ID:20609						
EP_NO: N/A						
Repair Type: Non-Urgent						
Crossing Status: Found						
UCIP Comments: Pipe appears abandoned and if so should be done so properly.						
FIELD_STRUCT_DESC: 14-inch pipe through levee 20.0 feet below crown, 2 pumps and gate valves discharge into surge tank in pump house on the waterward slope. Concrete distribution box removed from the waterward slope. Abandoned 36-inch diameter concrete standpipe on LS toe next to service pole. Originally included in the 1964 O&M manual.						
FS Date: 8/20/2013

Pipes at connection to concrete surge box on WS inside pumphouse.

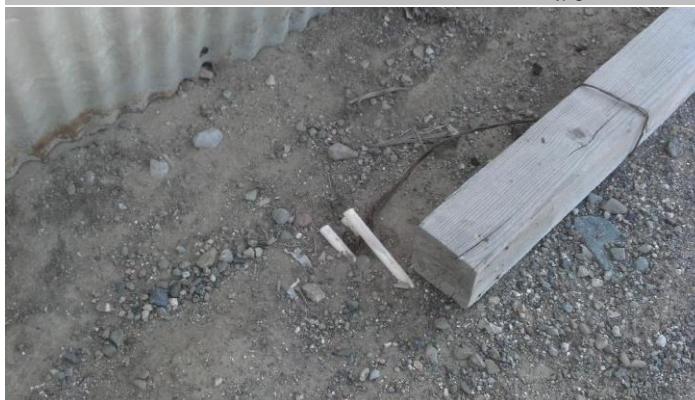
Photo 1 of 2 : UCIP\_SP\_2017\_21865\_37121.jpg

LM Start	1.81	Rating **	M	Issue No.	945
LM End	1.81	Issue Type +	En	Location *	LS
Category	Supplemental			GPS Latitude/Longitude	
				Start	End
Item	DWR UCIP Field Study			37.925431 °	37.925431 °
				-121.325310 °	-121.325310 °
DWR ID					
Comment Code					
Inspector Comment					
FS_ID:21865 DS_ID:24033 EP_NO: N/A Repair Type: Non-Urgent Crossing Status: Found UCIP Comments: Pipes appear abandoned and should be removed from levee. FIELD_STRUCT_DESC: *ABANDONED* One 1-inch and two 3/4-inch PVC conduits through the levee 6-inches below the crown. FS Date: 8/20/2013

Pipes visible on WS shoulder directly in front of pumphouse.

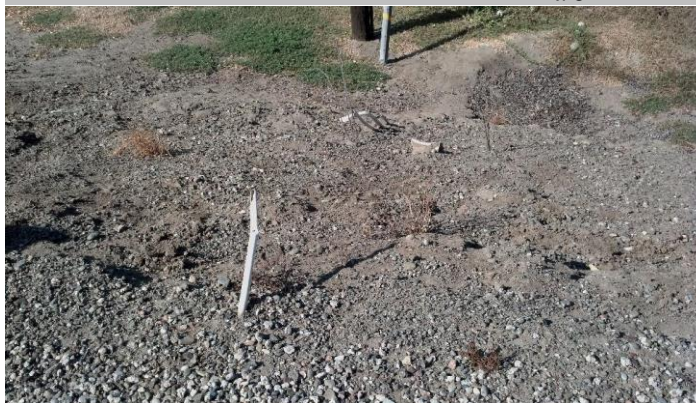
Photo 2 of 2 : UCIP\_SP\_2017\_21865\_37120.jpg

LM Start	1.81	Rating **	M	Issue No.	945 (cont)
LM End	1.81	Issue Type +	En	Location *	LS
Category	Supplemental			GPS Latitude/Longitude	
				Start	End
Item	DWR UCIP Field Study			37.925431 °	37.925431 °
				-121.325310 °	-121.325310 °
DWR ID					
Comment Code					
Inspector Comment					
FS_ID:21865 DS_ID:24033 EP_NO: N/A Repair Type: Non-Urgent Crossing Status: Found UCIP Comments: Pipes appear abandoned and should be removed from levee. FIELD_STRUCT_DESC: *ABANDONED* One 1-inch and two 3/4-inch PVC conduits through the levee 6-inches below the crown. FS Date: 8/20/2013

Pipes visible on LS slope.

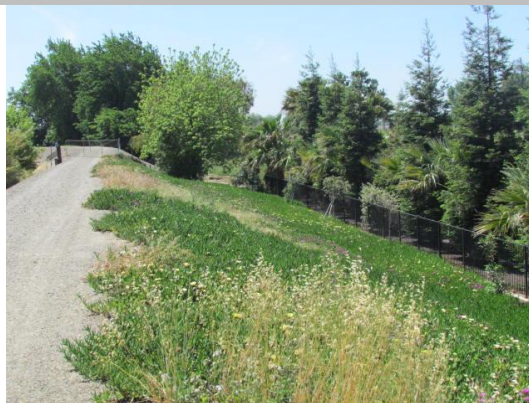
Photo 1 of 1 : SP\_2017\_RD0524\_107\_78\_20170316\_00126.jpg

LM Start	1.90	Rating **	U	Issue No.	78
LM End	1.94	Issue Type +	En	Location *	LS
Category	Earthen Levee			GPS Latitude/Longitude	
				Start	End
Item	Vegetation			37.924364 °	37.923805 °
				-121.324473 °	-121.324238 °
DWR ID	DWR_RD0524_01_s_2012_78				
Comment Code					
V6 : Landscaping					
Inspector Comment

Looking southwest at landscaping on landside slope. (Spring 2012)

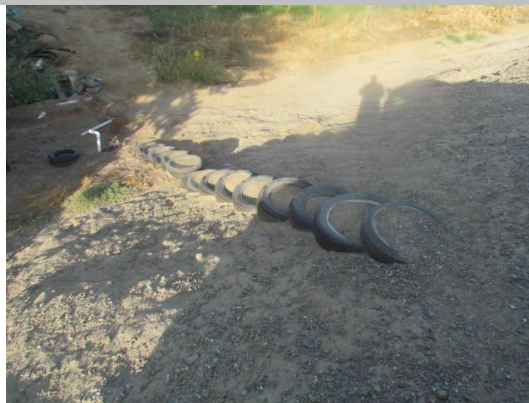
Photo 1 of 1 : SP\_2017\_RD0524\_107\_4\_20170316\_00010.jpg

LM Start	1.99	Rating **	M	Issue No.	4
LM End	1.99	Issue Type +	En	Location *	LS
Category	Earthen Levee			GPS Latitude/Longitude	
				Start	End
Item	Encroachments			37.923068 °	37.923068 °
				-121.323990 °	-121.323990 °
DWR ID	DWR_RD0524_01_f_2012_4				
Comment Code					
ST : Stairway					
Inspector Comment					
Landowner installed rubber tires for a stairway on landside slope.

Looking west at rubber tires being used as stairs on landside slope.

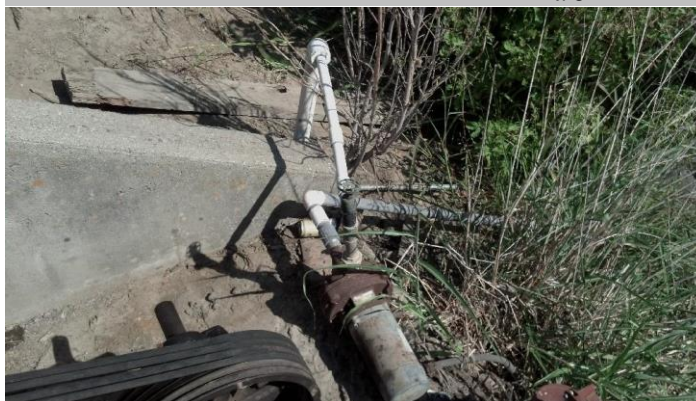
Photo 1 of 3 : UCIP\_SP\_2017\_21872\_37128.jpg

LM Start	1.99	Rating **	M	Issue No.	946
LM End	1.99	Issue Type +	En	Location *	LS
Category	Supplemental			GPS Latitude/Longitude	
				Start	End
Item	DWR UCIP Field Study			37.923022 °	37.923022 °
				-121.323953 °	-121.323953 °
DWR ID					
Comment Code					
Inspector Comment					
FS_ID:21872 DS_ID:24035 EP_NO: N/A Repair Type: Non-Urgent Crossing Status: Found UCIP Comments: No permit identified for this crossing. FIELD_STRUCT_DESC: 3-inch PVC domestic non-potable water line through the levee at unknowd depth below the crown. Pump on concrete pad at WS toe. FS Date: 8/20/2013

Pump on concrete pad at WS slope.

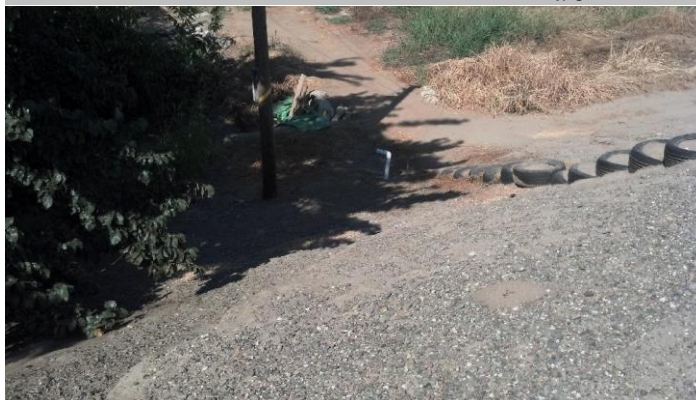
Photo 2 of 3 : UCIP\_SP\_2017\_21872\_37127.jpg

FS\_ID:21872  
DS\_ID:24035  
EP\_NO: N/A  
Repair Type: Non-Urgent  
Crossing Status: Found  
UCIP Comments: No permit identified for this crossing.  
FIELD\_STRUCT\_DESC: 3-inch PVC domestic non-potable water line through the levee at unknown depth below the crown. Pump on concrete pad at WS toe.  
FS Date: 8/20/2013

PVC pipe visible on LS toe.

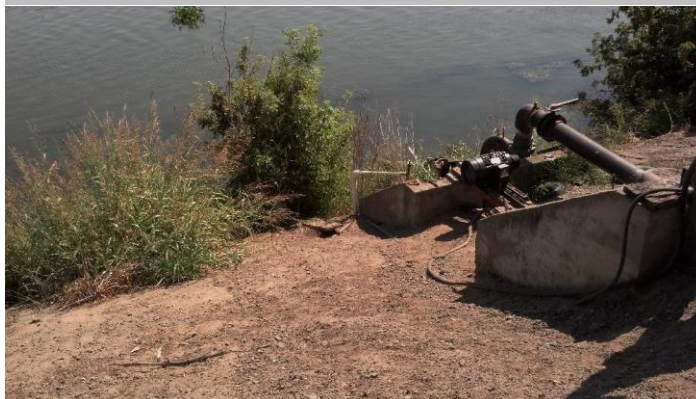
Photo 3 of 3 : UCIP\_SP\_2017\_21872\_37126.jpg

Pump and pipe visible on WS slope.

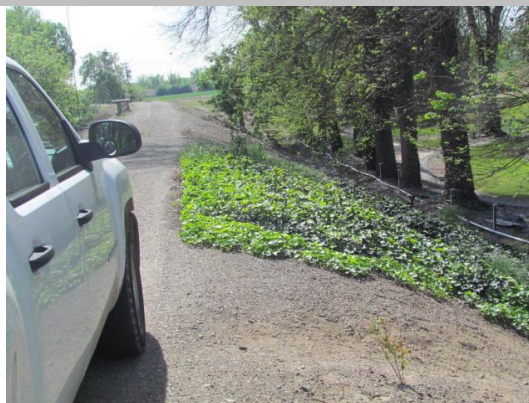
Photo 1 of 1 : SP\_2017\_RD0524\_107\_106\_20170316\_00164.jpg

LM Start	2.00	Rating **	U	Issue No.	106
LM End	2.00	Issue Type +	En	Location *	LS
Category	Earthen Levee			GPS Latitude/Longitude	
				Start	End
Item	Vegetation			37.922923 °	37.922923 °
				-121.323837 °	-121.323837 °
DWR ID	DWR_RD0524_01_s_2012_106				
Comment Code					
V6 : Landscaping					
Inspector Comment

Looking southwest at ground cover on landward slope.

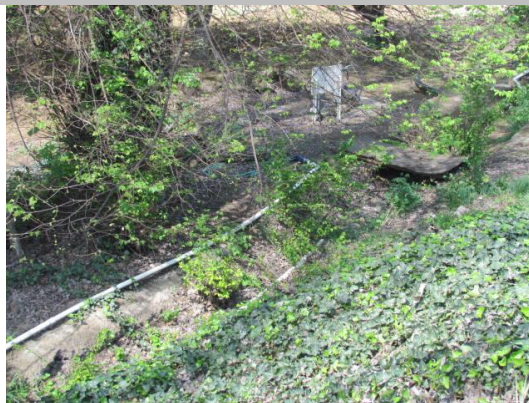
Photo 1 of 2 : SP\_2017\_RD0524\_107\_182\_20170316\_00218.jpg

LM Start	2.01	Rating **	M	Issue No.	182
LM End	2.04	Issue Type +	En	Location *	LS
Category	Earthen Levee			GPS Latitude/Longitude	
				Start	End
Item	Encroachments			37.922837 °	37.922514 °
				-121.323785 °	-121.323504 °
DWR ID	DWR_RD0524_01_s_2014_182				
Comment Code					
DT : Ditch					
Inspector Comment					
Old irrigation ditch at the landward toe should be removed.

Looking northwest at an old irrigation ditch at landward toe.

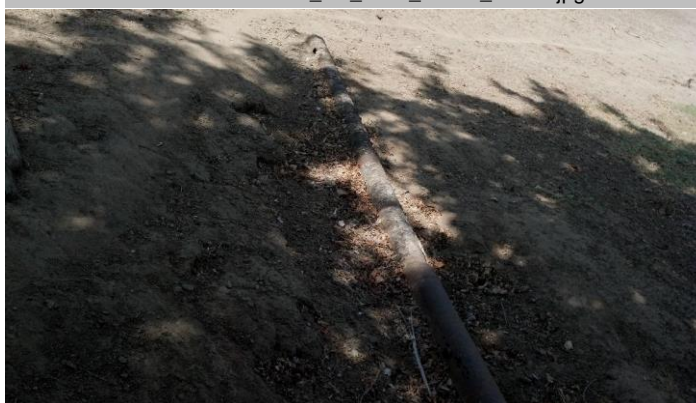
Photo 1 of 2 : UCIP\_SP\_2017\_21883\_37134.jpg

FS\_ID:21883  
DS\_ID:24036  
EP\_NO: N/A  
Repair Type: Non-Urgent  
Crossing Status: Found  
UCIP Comments: Pipe abandoned and should be done so properly.  
Holes visible throughout exposed pipe.  
FIELD\_STRUCT\_DESC: 5-inch wrapped steel irrigation pipe through the levee 6-feet below the crown. No pump or other appurtenances found.  
FS Date: 8/20/2013

Pipe visible on WS slope.

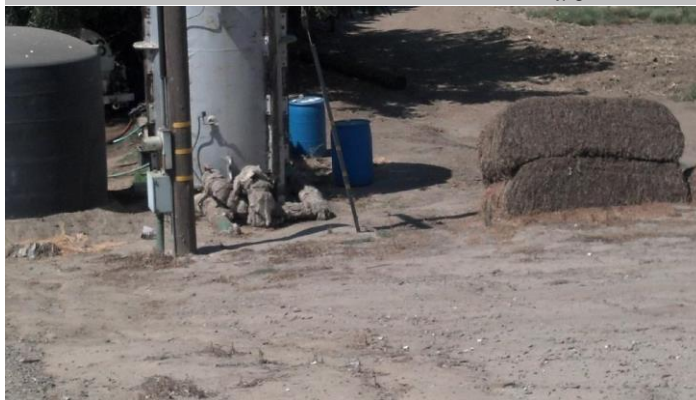
Photo 1 of 3 : UCIP\_SP\_2017\_21895\_37142.jpg

LM Start	2.07	Rating **	M	Issue No.	948
LM End	2.07	Issue Type +	En	Location *	WS
Category	Supplemental			GPS Latitude/Longitude	
				Start	End
Item	DWR UCIP Field Study			37.922080 °	37.922080 °
				-121.323118 °	-121.323118 °
DWR ID					
Comment Code					
Inspector Comment					
FS_ID:21895 DS_ID:24038 EP_NO: N/A Repair Type: Non-Urgent Crossing Status: Found UCIP Comments: No permit identified for this crossing. FIELD_STRUCT_DESC: 6-inch steel irrigation pipe through the levee at an unknown depth. Vent, meter, butterfly valve, and pump at pumphouse on WS slope. FS Date: 8/20/2013

Steel irrigation line visible in front of tank to right of powerpole off LS toe.

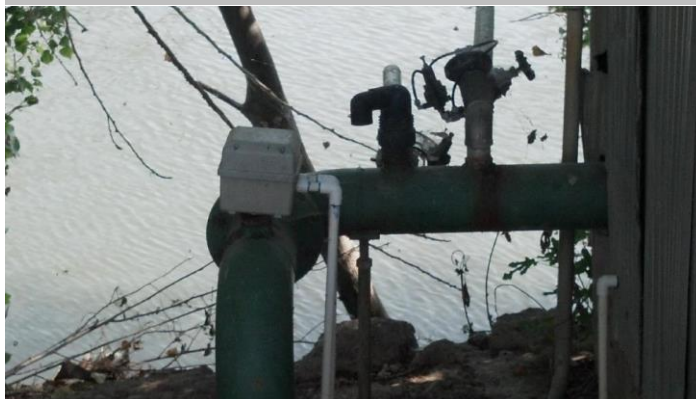
Photo 2 of 3 : UCIP\_SP\_2017\_21895\_37141.jpg

Irrigation line visible on side of pumphouse.

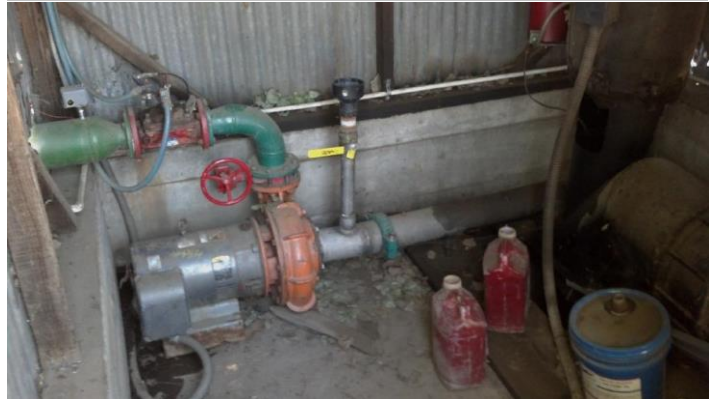
Photo 3 of 3 : UCIP\_SP\_2017\_21895\_37140.jpg

LM Start	2.07	Rating **	M	Issue No.	948 (cont)
LM End	2.07	Issue Type +	En	Location *	WS
Category	Supplemental			GPS Latitude/Longitude	
				Start	End
Item	DWR UCIP Field Study			37.922080 °	37.922080 °
				-121.323118 °	-121.323118 °
DWR ID					
Comment Code					
Inspector Comment					
FS_ID:21895 DS_ID:24038 EP_NO: N/A Repair Type: Non-Urgent Crossing Status: Found UCIP Comments: No permit identified for this crossing. FIELD_STRUCT_DESC: 6-inch steel irrigation pipe through the levee at an unknown depth. Vent, meter, butterfly valve, and pump at pumphouse on WS slope. FS Date: 8/20/2013

Pump and butterfly valve inside pumphouse on WS berm.

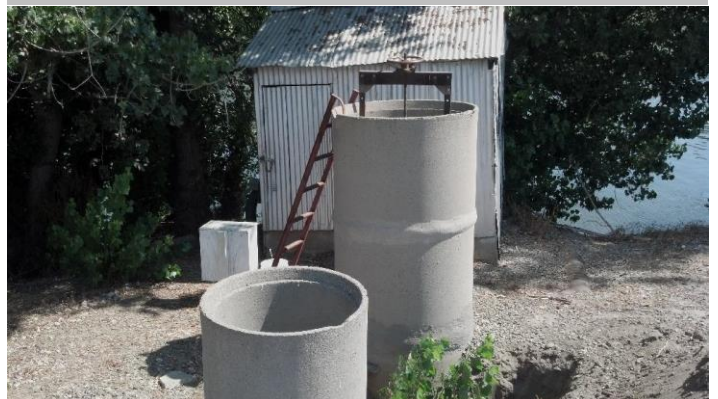
Photo 1 of 3 : UCIP\_SP\_2017\_17944\_30045.jpg

LM Start	2.07	Rating **	M	Issue No.	949
LM End	2.07	Issue Type +	En	Location *	WS
Category	Supplemental			GPS Latitude/Longitude	
				Start	End
Item	DWR UCIP Field Study			37.922064 °	37.922064 °
				-121.323084 °	-121.323084 °
DWR ID					
Comment Code					
Inspector Comment					
FS_ID:17944 DS_ID:20612 EP_NO: N/A Repair Type: Non-Urgent Crossing Status: Found UCIP Comments: Soil excavated from cover over pipe on WS next to concrete riser. May indicate a leak or other problem. FIELD_STRUCT_DESC: 20-inch steel pipe through the levee 15.0 feet below the crown. Pump in pump house on the waterward slope. Slide gate in 4-foot diameter concrete standpipe on WS slope with secondary concrete standpipe. PVC standpipe visible 350-feet off LS toe. Originally included in the 1964 O&M manual. FS Date: 8/20/2013

Slide gate in concrete riser with secondary concrete riser in foreground. Pumphouse in background.

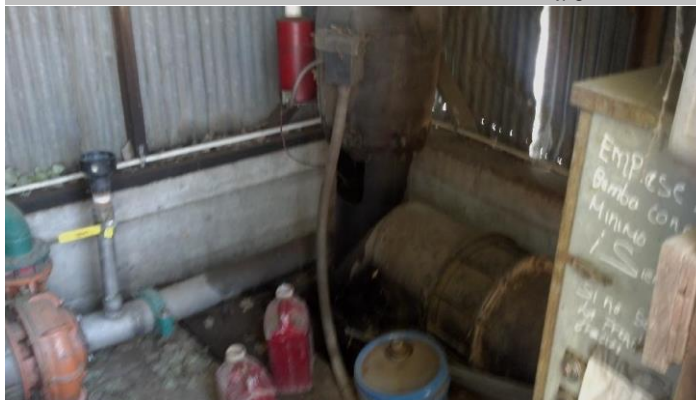
Photo 2 of 3 : UCIP\_SP\_2017\_17944\_30044.jpg

Pump and pipe inside pumphouse.

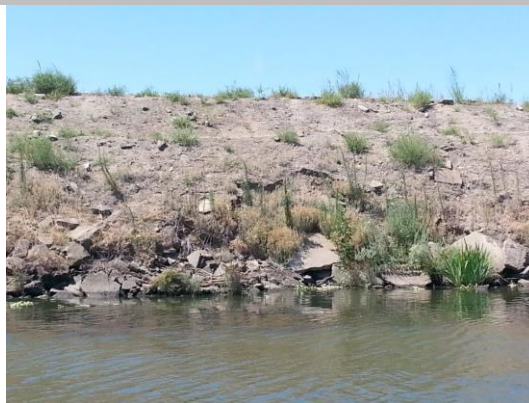
Photo 1 of 2 : SP\_2017\_RD0524\_107\_91\_20170316\_00147.jpg

LM Start	2.19	Rating **	U	Issue No.	91
LM End	2.19	Issue Type +	Ma	Location *	WS
Category	Supplemental			GPS Latitude/Longitude	
				Start	End
Item	DWR Erosion Survey			37.920992 °	37.920992 °
				-121.321370 °	-121.321370 °
DWR ID	DWR_RD0524_01_s_2017_91				
Comment Code					
Inspector Comment					
07/25/2016: No significant change observed.					
06/24/2015: No significant change observed.					
07/22/2014: The erosion has increased in size.					
08/13/2013: No significant change observed. Slightly more vegetation was visible.					
08/07/2012: The site was first reported in 2012 spring levee inspection report. [2016 Site ID:RD0524U01RM42.79]

Close view of the pocket erosion.

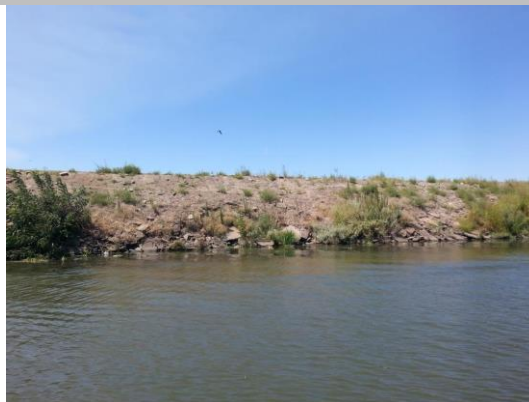
Photo 2 of 2 : SP\_2017\_RD0524\_107\_91\_20170316\_00148.jpg

Front view of the erosion.

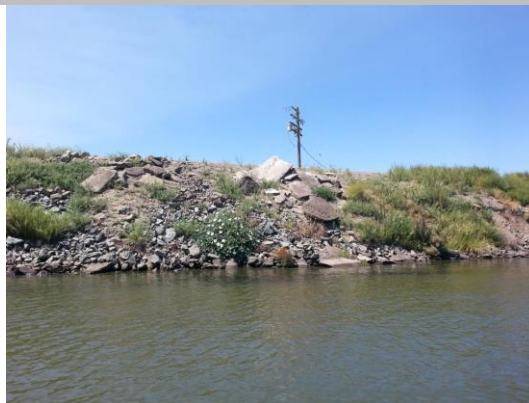
Photo 1 of 3 : SP\_2017\_RD0524\_107\_99\_20170316\_00158.jpg

LM Start	2.24	Rating **	U	Issue No.	99
LM End	2.27	Issue Type +	Ma	Location *	WS
Category	Supplemental			GPS Latitude/Longitude	
				Start	End
Item	DWR Erosion Survey			37.920650 °	37.920650 °
				-121.320370 °	-121.320370 °
DWR ID	DWR_RD0524_01_s_2017_99				
Comment Code					
Inspector Comment					
0/03/20167: Site repaired					
07/25/2016: No significant change observed.					
06/24/2015: No significant change observed.					
06/19/2014: No significant change observed.					
08/13/2013: An irrigation pipe is on site. [2016 Site					
ID:RD0524U01RM42.84]

Close view of the erosion.

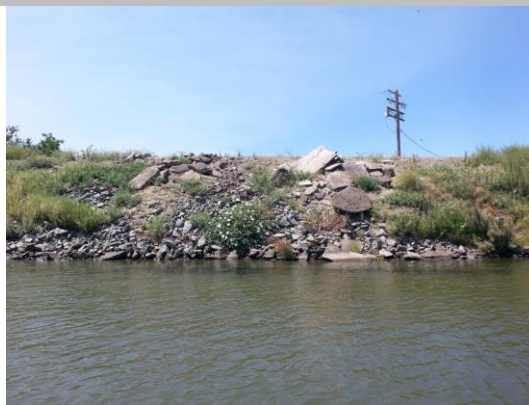
Photo 2 of 3 : SP\_2017\_RD0524\_107\_99\_20170316\_00159.jpg

Close view of the erosion.

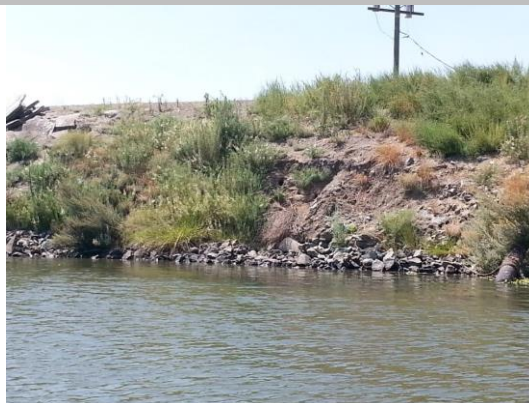
Photo 3 of 3 : SP\_2017\_RD0524\_107\_99\_20170316\_00160.jpg

Close view of the erosion. Note the irrigation pipe next to the erosion.

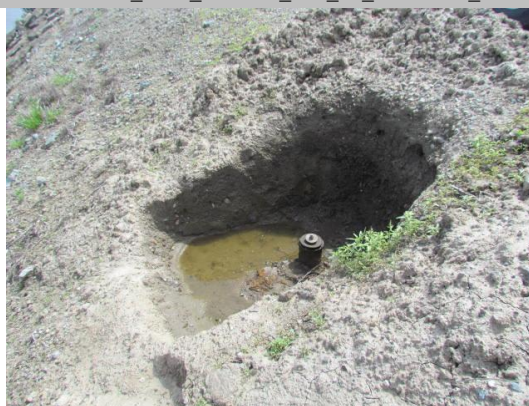
Photo 1 of 3 : SP\_2017\_RD0524\_107\_31\_20170316\_00058.jpg

LM Start	2.25	Rating **	U	Issue No.	31
LM End	2.25	Issue Type +	Ma	Location *	WS
Category	Earthen Levee			GPS Latitude/Longitude	
				Start	End
Item	Slope Stability			37.920493 °	37.920493 °
				-121.320565 °	-121.320565 °
DWR ID	DWR_RD0524_01_s_2012_31				
Comment Code					
S1 : Repair slope instability.					
Inspector Comment					
Slope instability probably cause by leak in irrigation pipe. Pipe should be inspected internally.

Looking south at siphon on waterward slope.

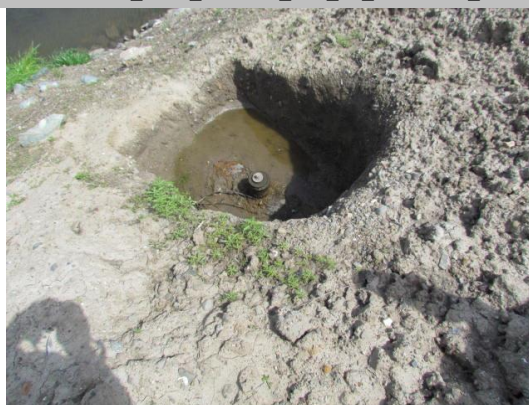
Photo 2 of 3 : SP\_2017\_RD0524\_107\_31\_20170316\_00059.jpg

Looking east at siphon on waterward slope.

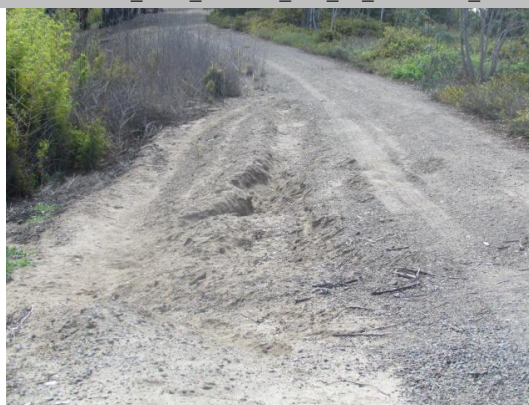
Photo 3 of 3 : SP\_2017\_RD0524\_107\_31\_20170316\_00060.jpg

Looking south slope damage on waterward shoulder and slope.

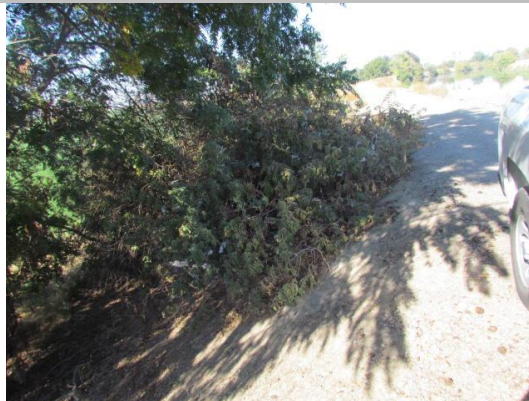
Photo 1 of 2 : SP\_2017\_RD0524\_107\_32\_20170316\_00061.jpg

LM Start	2.27	Rating **	U	Issue No.	32
LM End	2.29	Issue Type +	Ma	Location *	LS
Category	Earthen Levee			GPS Latitude/Longitude	
				Start	End
Item	Vegetation			37.920372 °	37.920167 °
				-121.320230 °	-121.319890 °
DWR ID	DWR_RD0524_01_s_2012_32				
Comment Code					
V4 : Elderberries are blocking visibility and flood fight capability.					
Inspector Comment					
Dense elderberry bushes on landward slope and toe.

Looking northwest at dense veg on landward slope and toe fall 2015.

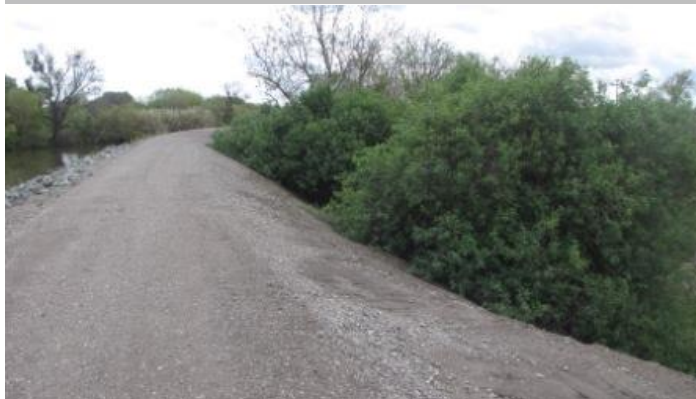
Photo 2 of 2 : SP\_2017\_RD0524\_107\_32\_20170316\_00062.jpg

Looking south at dense veg on landside slope and toe.

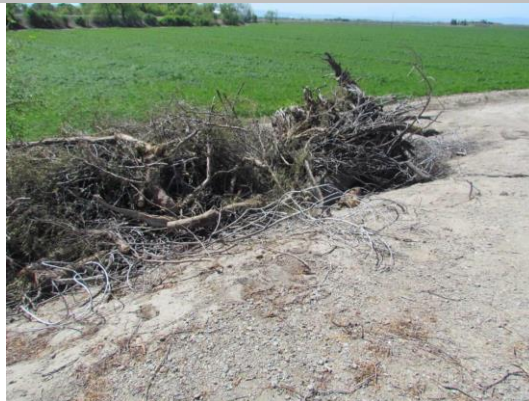
Photo 1 of 1 : SP\_2017\_RD0524\_107\_203\_20170407\_00385.jpg

LM Start	2.27	Rating **	U	Issue No.	203
LM End	2.27	Issue Type +	Ma	Location *	LS
Category	Earthen Levee			GPS Latitude/Longitude	
				Start	End
Item	Encroachments			37.920327 °	37.920327 °
				-121.320175 °	-121.320175 °
DWR ID	DWR_RD0524_01_f_2016_203				
Comment Code					
PR : Prunings					
Inspector Comment					
Large pruning pile on landward slope and toe.

Looking west at pruning pile on waterward slope.

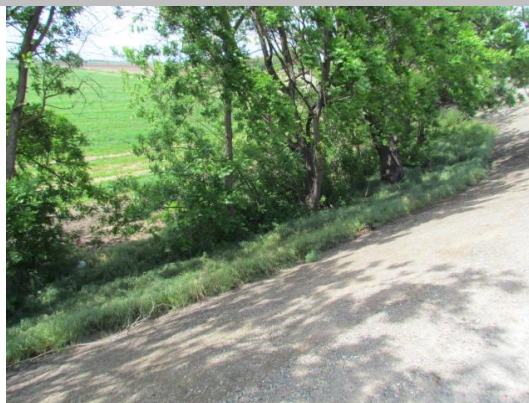
Photo 1 of 1 : SP\_2017\_RD0524\_107\_107\_20170316\_00165.jpg

LM Start	2.33	Rating **	U	Issue No.	107
LM End	2.33	Issue Type +	Ma	Location *	LS
Category	Earthen Levee			GPS Latitude/Longitude	
				Start	End
Item	Trim / Thin Trees			37.919742 °	37.919742 °
				-121.319623 °	-121.319623 °
DWR ID	DWR_RD0524_01_s_2012_107				
Comment Code					
T1 : Trim trees to at least five feet above ground level.					
Inspector Comment

Looking northwest at untrimmed trees at landward toe.

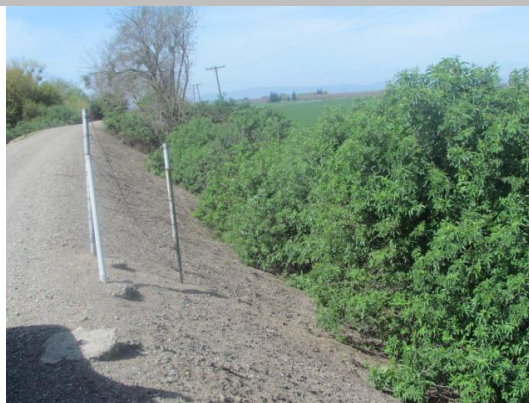
Photo 1 of 1 : SP\_2017\_RD0524\_107\_35\_20170316\_00066.jpg

LM Start	2.41	Rating **	U	Issue No.	35
LM End	2.45	Issue Type +	Ma	Location *	LS
Category	Earthen Levee			GPS Latitude/Longitude	
				Start	End
Item	Vegetation			37.918785 °	37.918515 °
				-121.320417 °	-121.321110 °
DWR ID	DWR_RD0524_01_s_2012_35				
Comment Code					
V4 : Elderberries are blocking visibility and flood fight capability.					
Inspector Comment

Looking southwest at dense vegetation on landward toe.
